## National Transportation Safety Board

### Safety Recommendation

**Date:** March 2, 2012

**In reply refer to:** R-12-5 through -8  
R-07-4 (Reiteration)

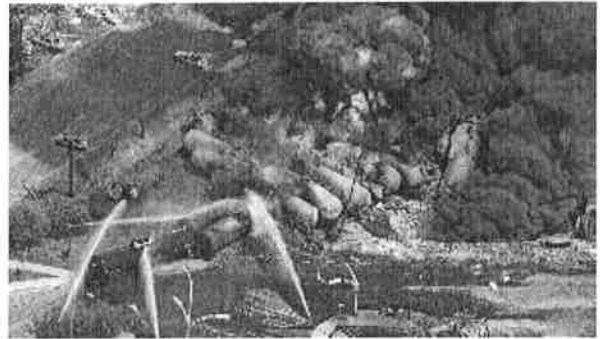
FILE - In this Tuesday, July 9, 2013 file photo, workers comb through debris after a train derailed three days earlier causing explosions of railway cars carrying crude oil in Lac-Mégantic, Quebec.

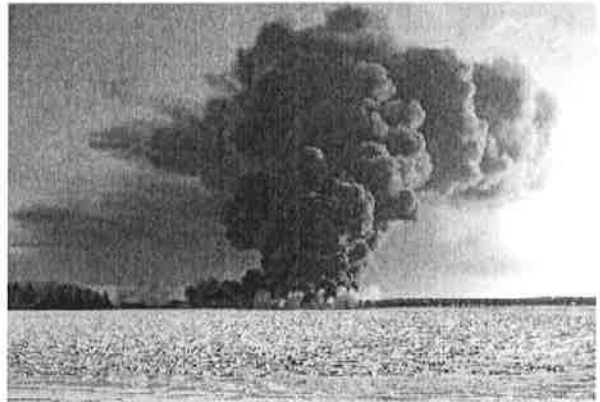
This photo provided by Cass County Commissioner Ken Pawluk shows a train derailment and fire west of Casselton, N.D., Monday, Dec. 30, 2013.
